Preliminary Geotechnical Engineering Report

Golf Club Road Subdivision
GeoPacific Project № 24-6715
January 17, 2025

Marion County Tax Map 09 1W 04B
Tax Lots 200, 900 & 1000
9164, 9384 & 9474 Golf Club Road SE
Stayton, Oregon

Brownstone Development
PO Box 2201
Lake Oswego, Oregon
Email: randy@brownstonehomes.net

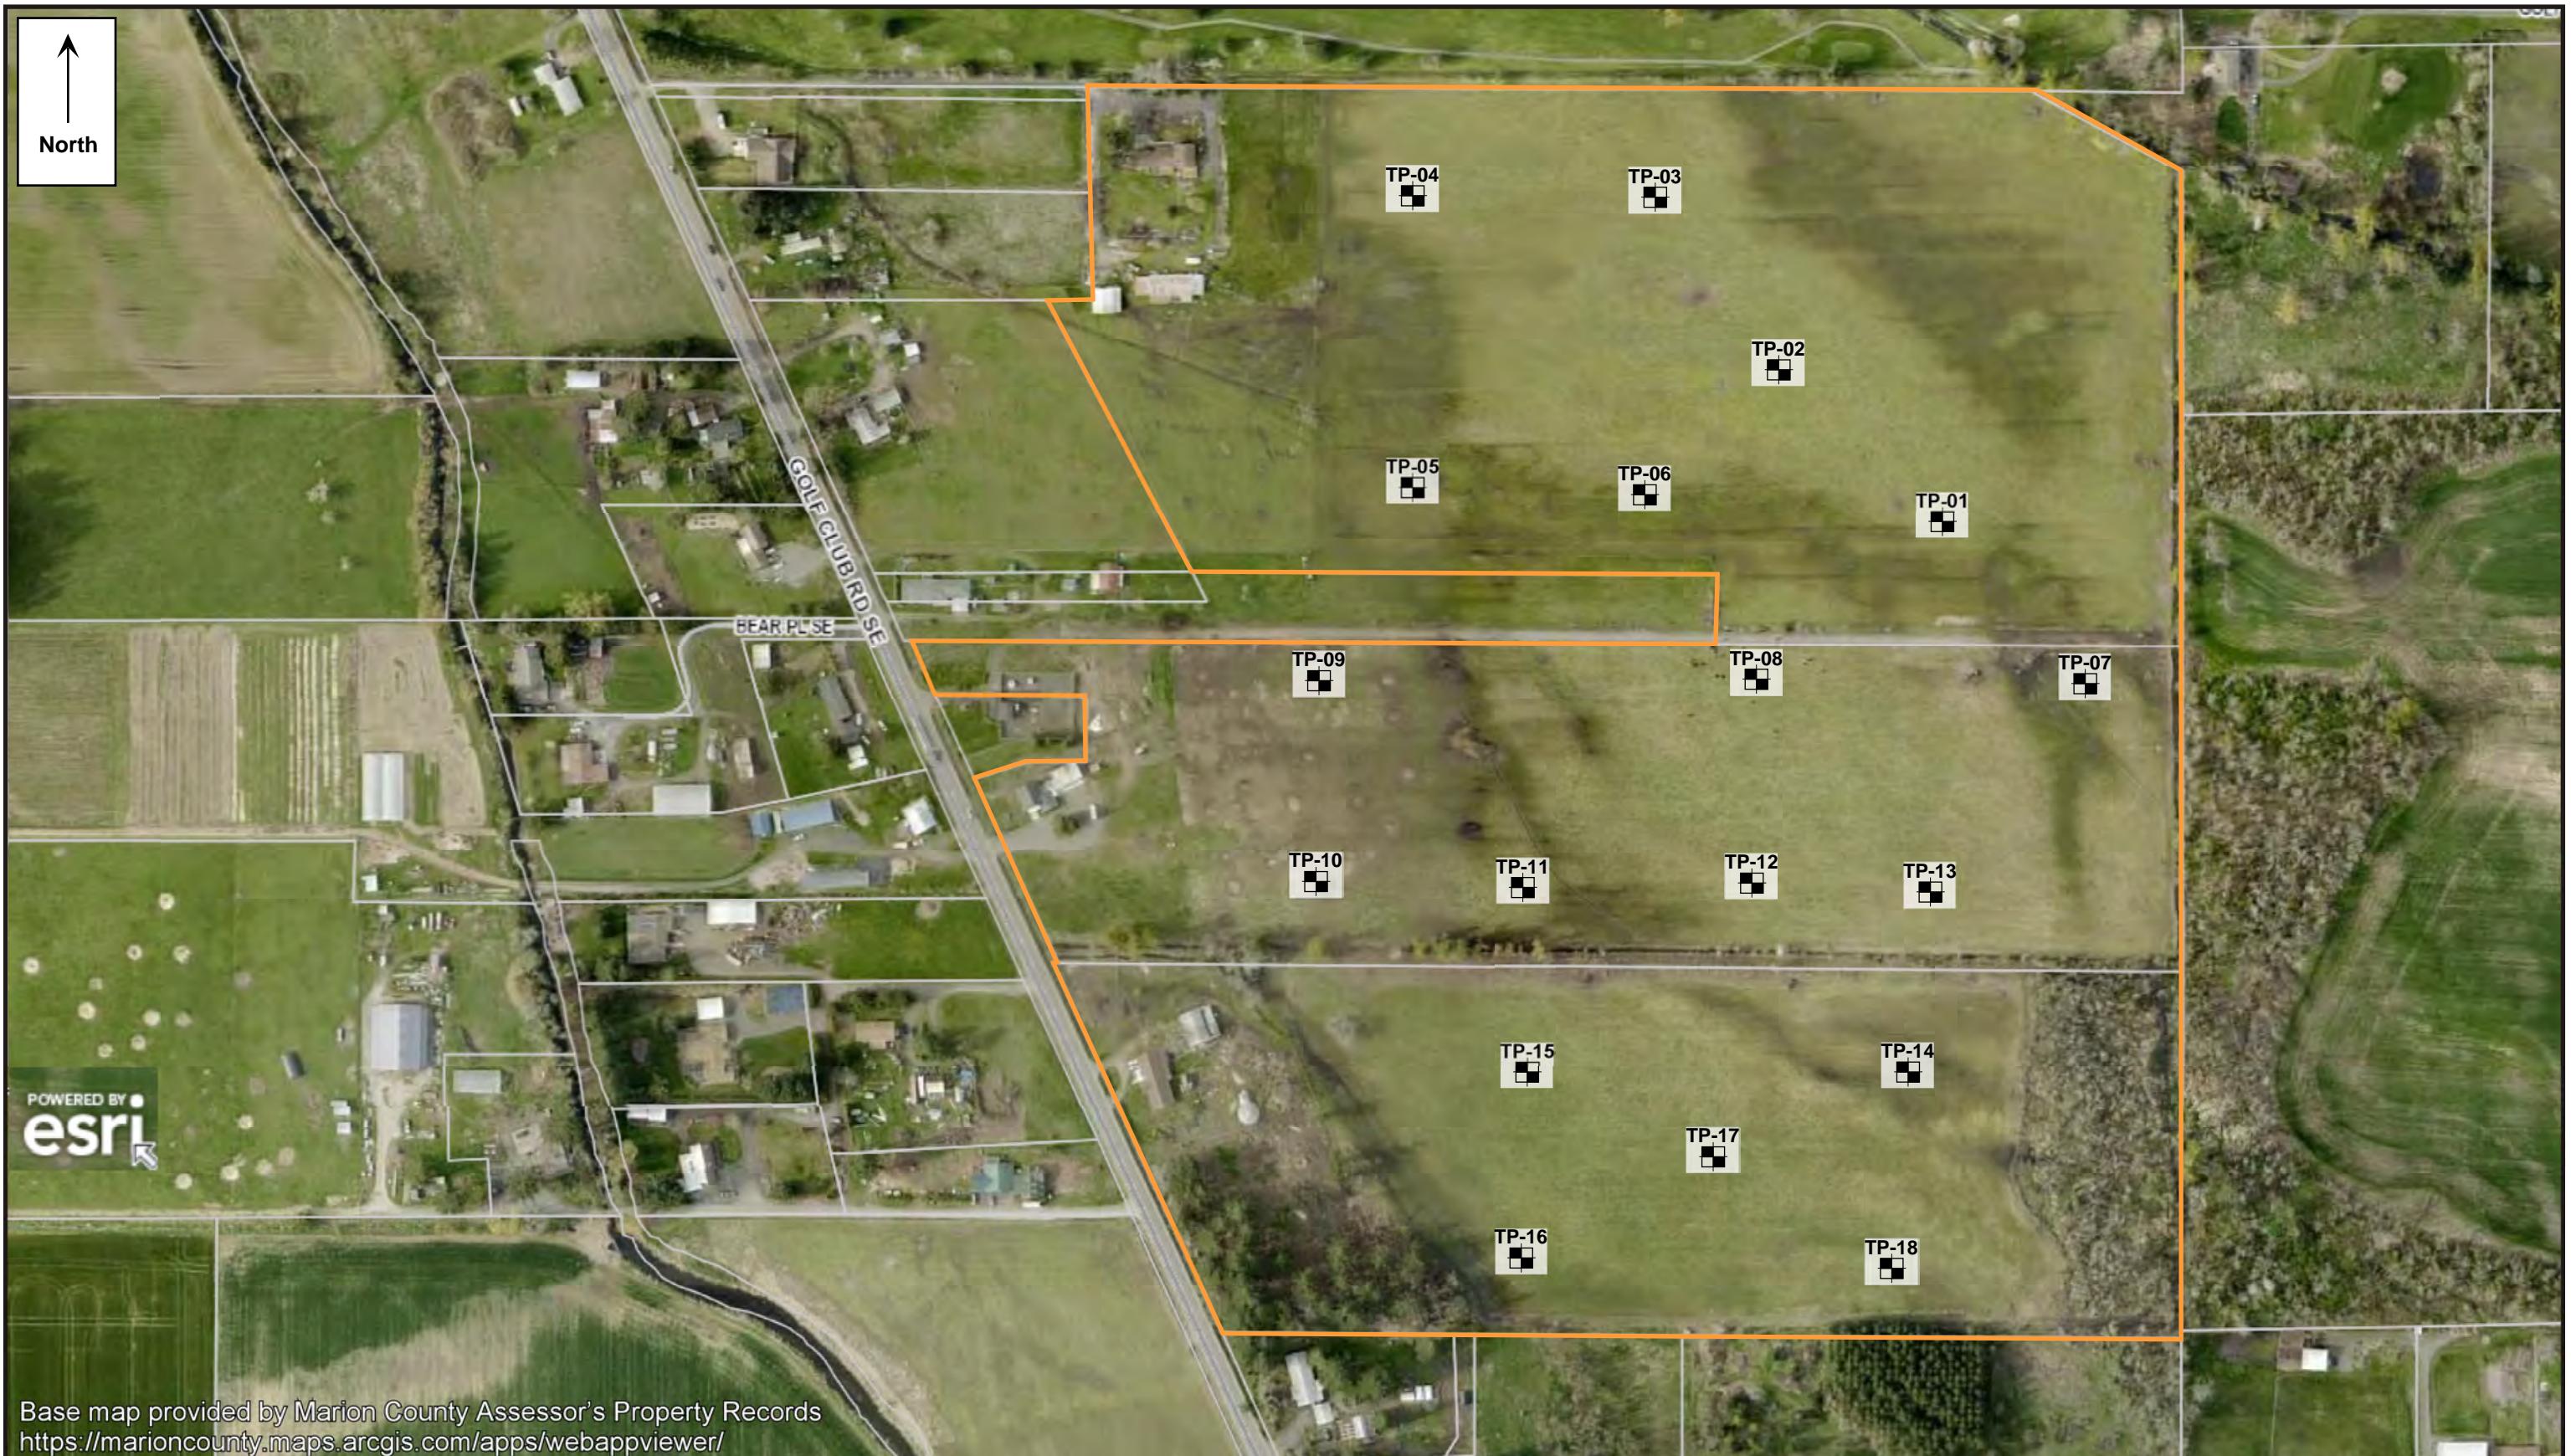
FIGURE 2

SITE AERIAL AND EXPLORATION LOCATIONS

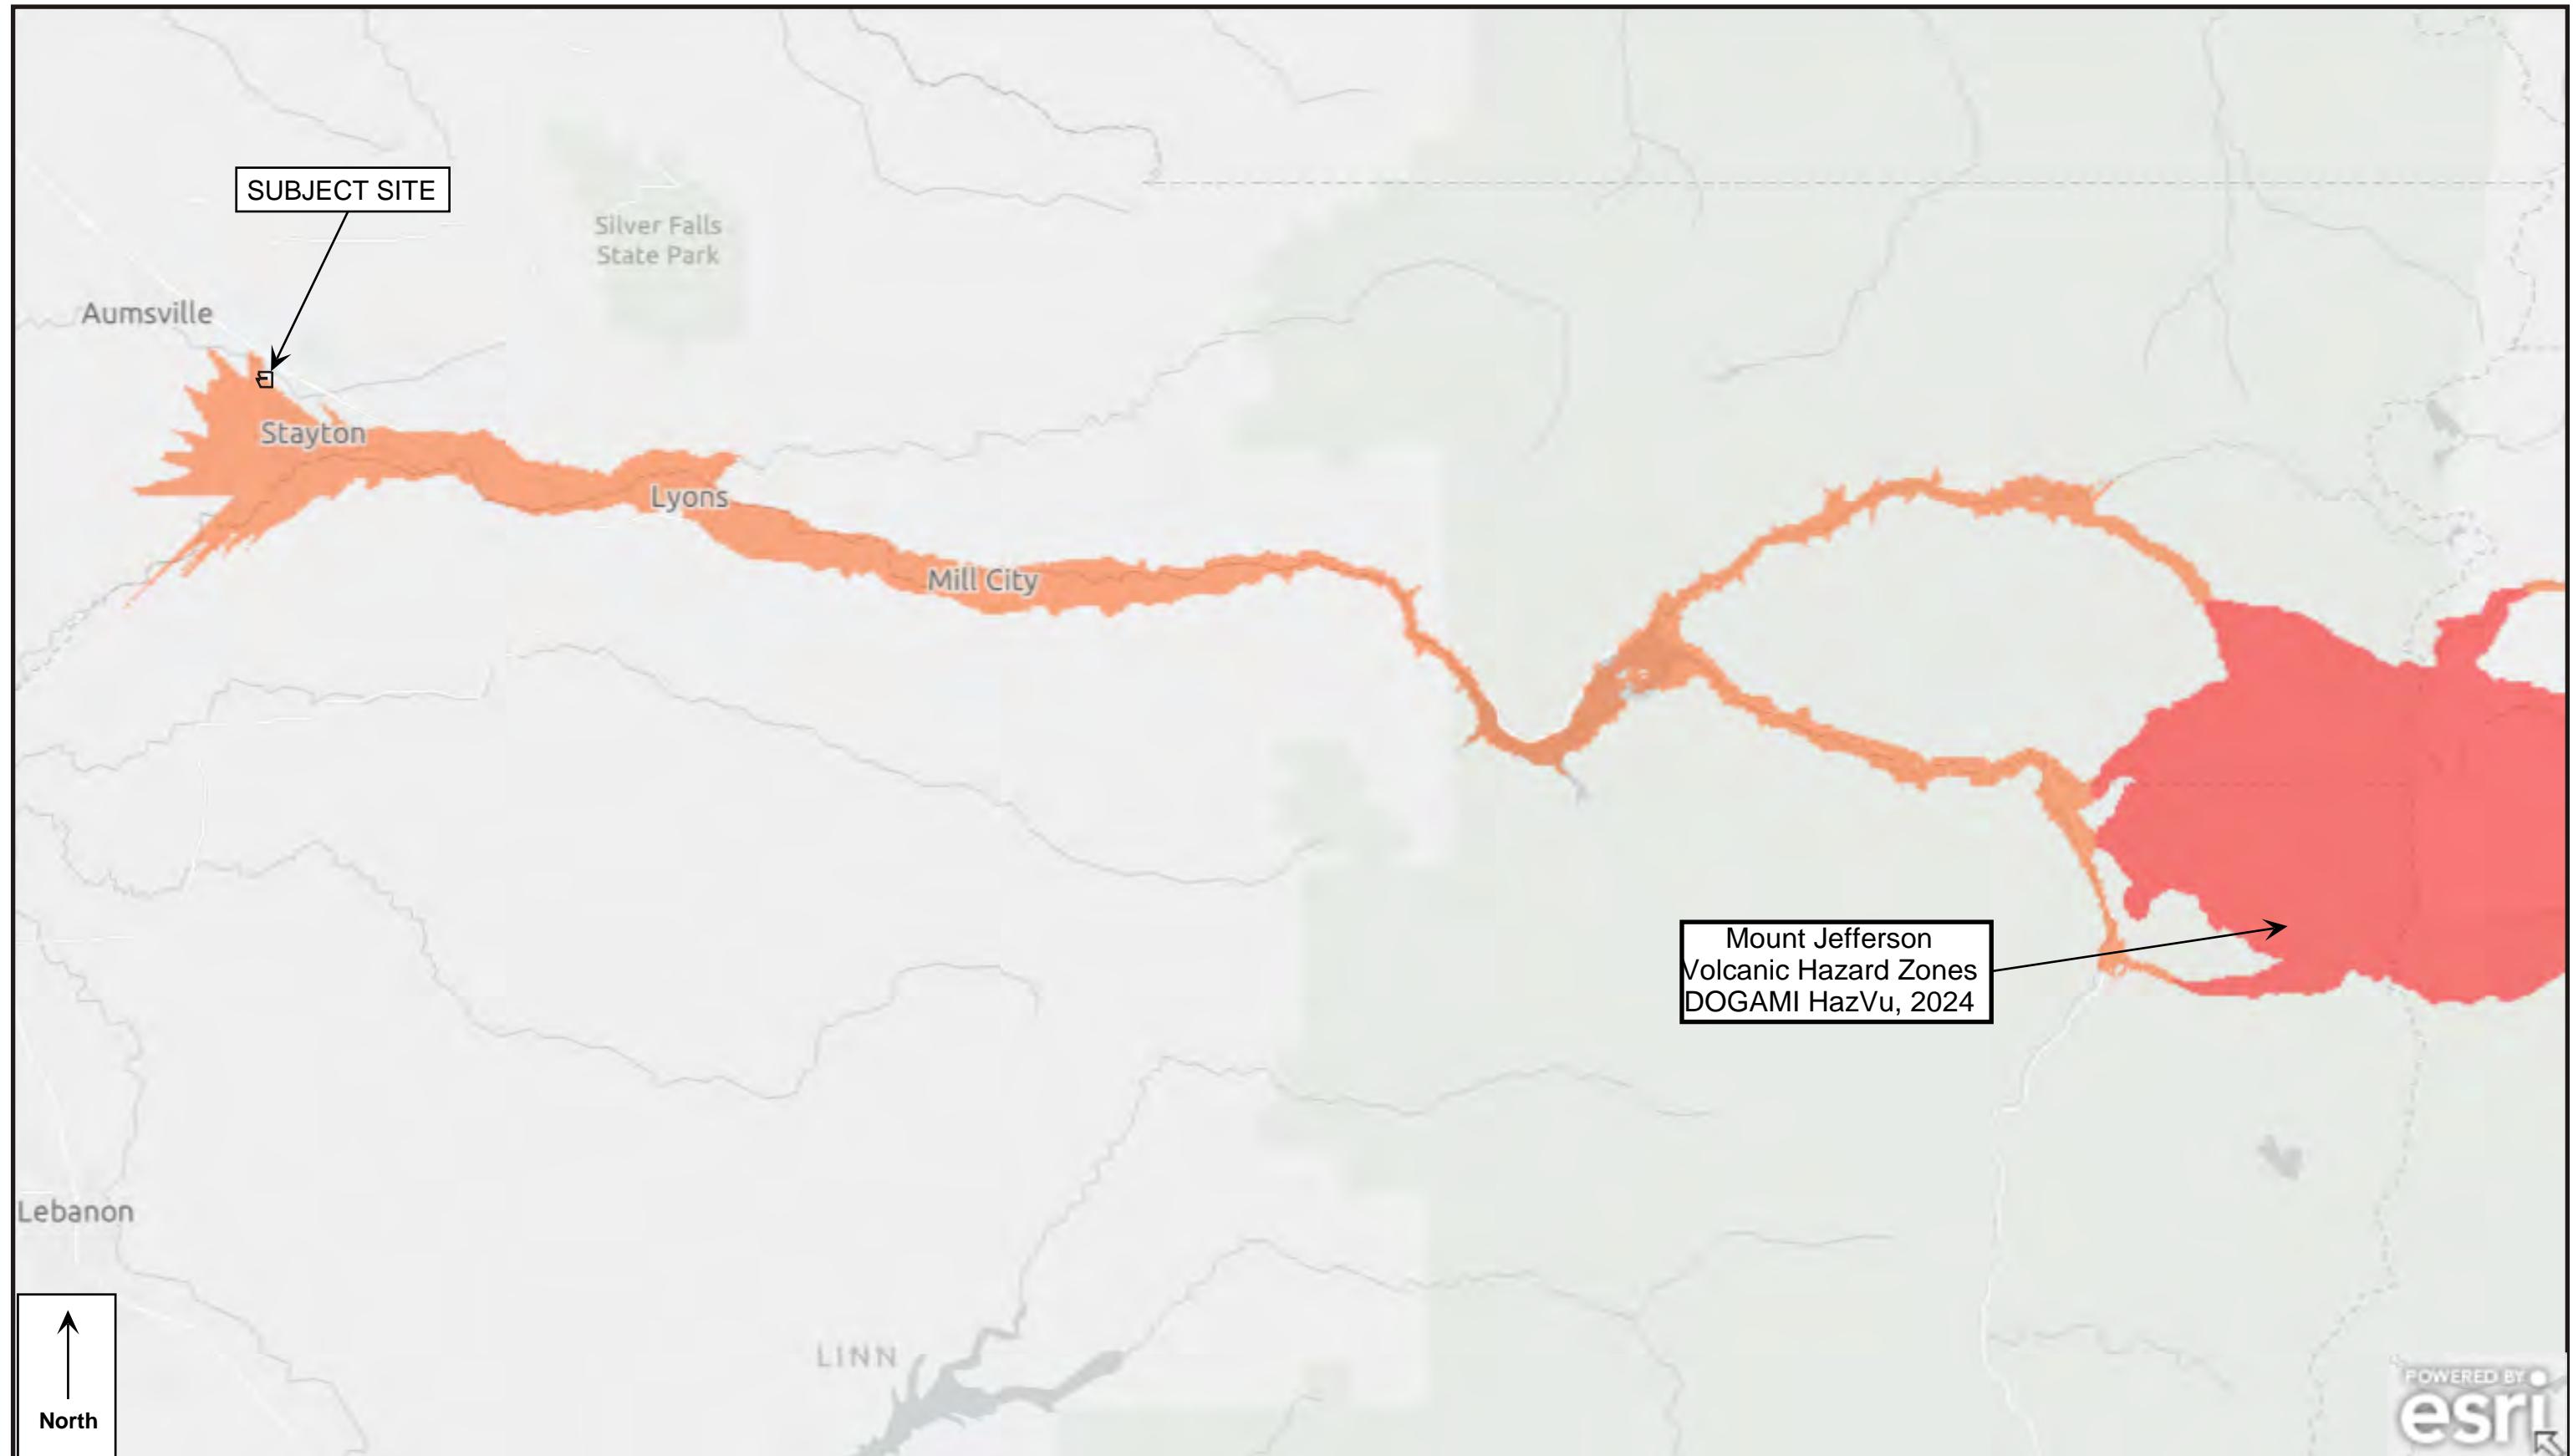
Volcano-hazards zones for the Mount Jefferson area are mapped by Walder et al. (1999) into proximal and distal hazard zones based on distance from the volcano (Figure 3). Areas within the Proximal Hazard Zones for Mount Jefferson are subject to rapid pyroclastic flows and surges, lahars, debris flows, ballistic projectiles and lava flows. Proximal Hazard Zones include areas approximately 5 to 10 miles from the summit of Mount Jefferson. Distal Hazard Zones are subject to lahars and debris avalanches. Proximal and Distal areas adjacent to Mount Jefferson are primarily mapped in the vicinity of the South Fork Breitenbush River, North Santiam River, Whitewater River, Metolius River and Shitike Creek. Figure 3 displays the Mount Jefferson volcanic hazard zone mapping as currently presented on the Oregon Department of Geology and Mineral Industries statewide geohazards viewer, as modified from the Proximal (High) Hazard and Distal (Moderate) Hazard classifications by Walder, et al. (1999).

**SITE AND
VOLCANIC HAZARD AREAS**
