**Report of
Infiltration Testing
Santiam Street Duplexes
1100 E Santiam Street
Marion County, Oregon**

CGT Project Number G2506341

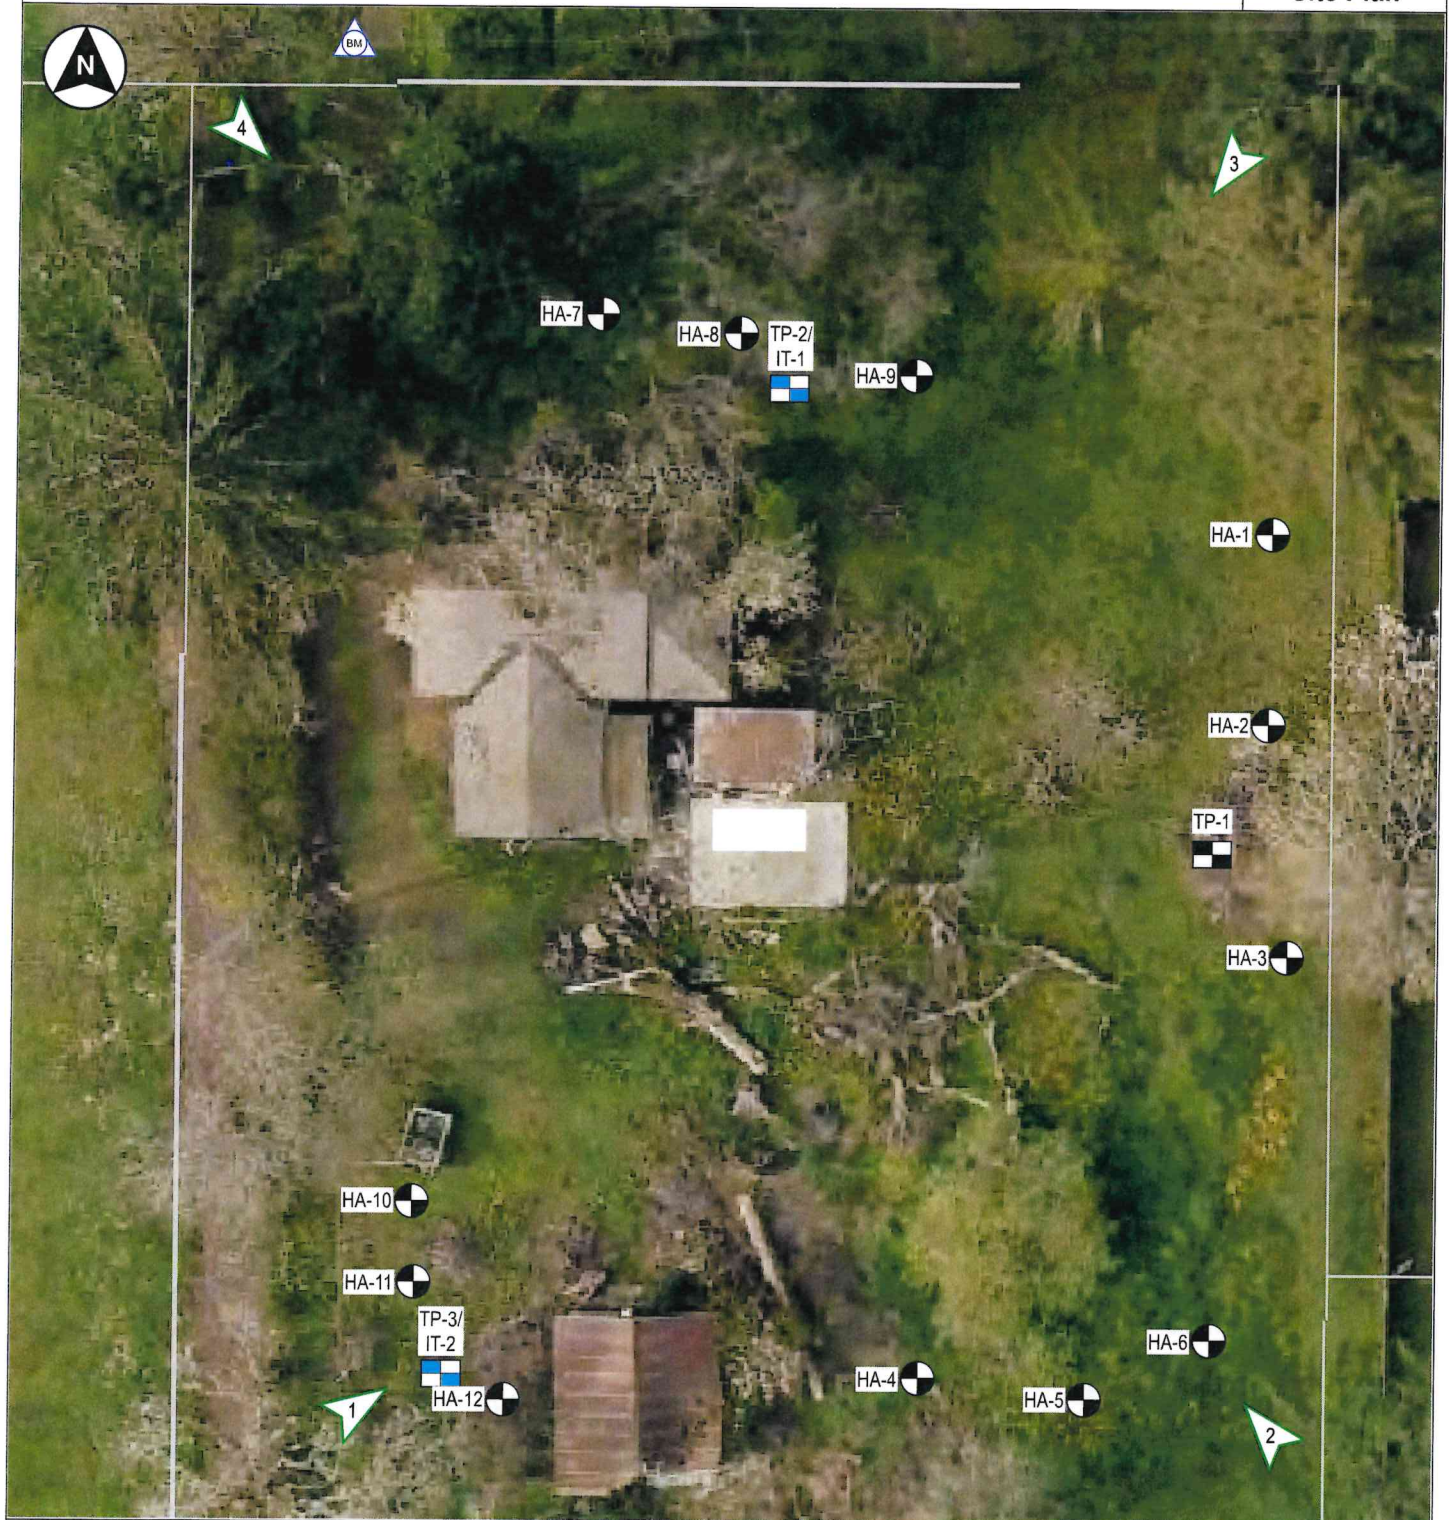
FIGURE 2
Site Plan

| HA-1 | | Hand auger boring advanced on January 31, 2025. | | Orientation of site photographs shown on Figure 3 |
| TP-2/IT-1 | | Test pit and infiltration test excavated on February 10, 2025. | | |

The site is bordered by residential properties to the south, west, and east, and E Santiam Street to the north. At the time of our field investigation, the relatively level site was occupied by an existing residential structure and a gravel-surfaced driveway. The remainder of the site was covered with short grasses, bushes, and trees. Site layout and surface conditions at the time of our field investigation are shown on the attached Site Plan (Figure 2) and Site Photographs (Figure 3).
