## **Preliminary Geotechnical Engineering Report**

**Golf Club Road Subdivision  
GeoPacific Project № 24-6715  
January 17, 2025**

**Marion County Tax Map 09 1W 04B  
Tax Lots 200, 900 & 1000  
9164, 9384 & 9474 Golf Club Road SE  
Stayton, Oregon**

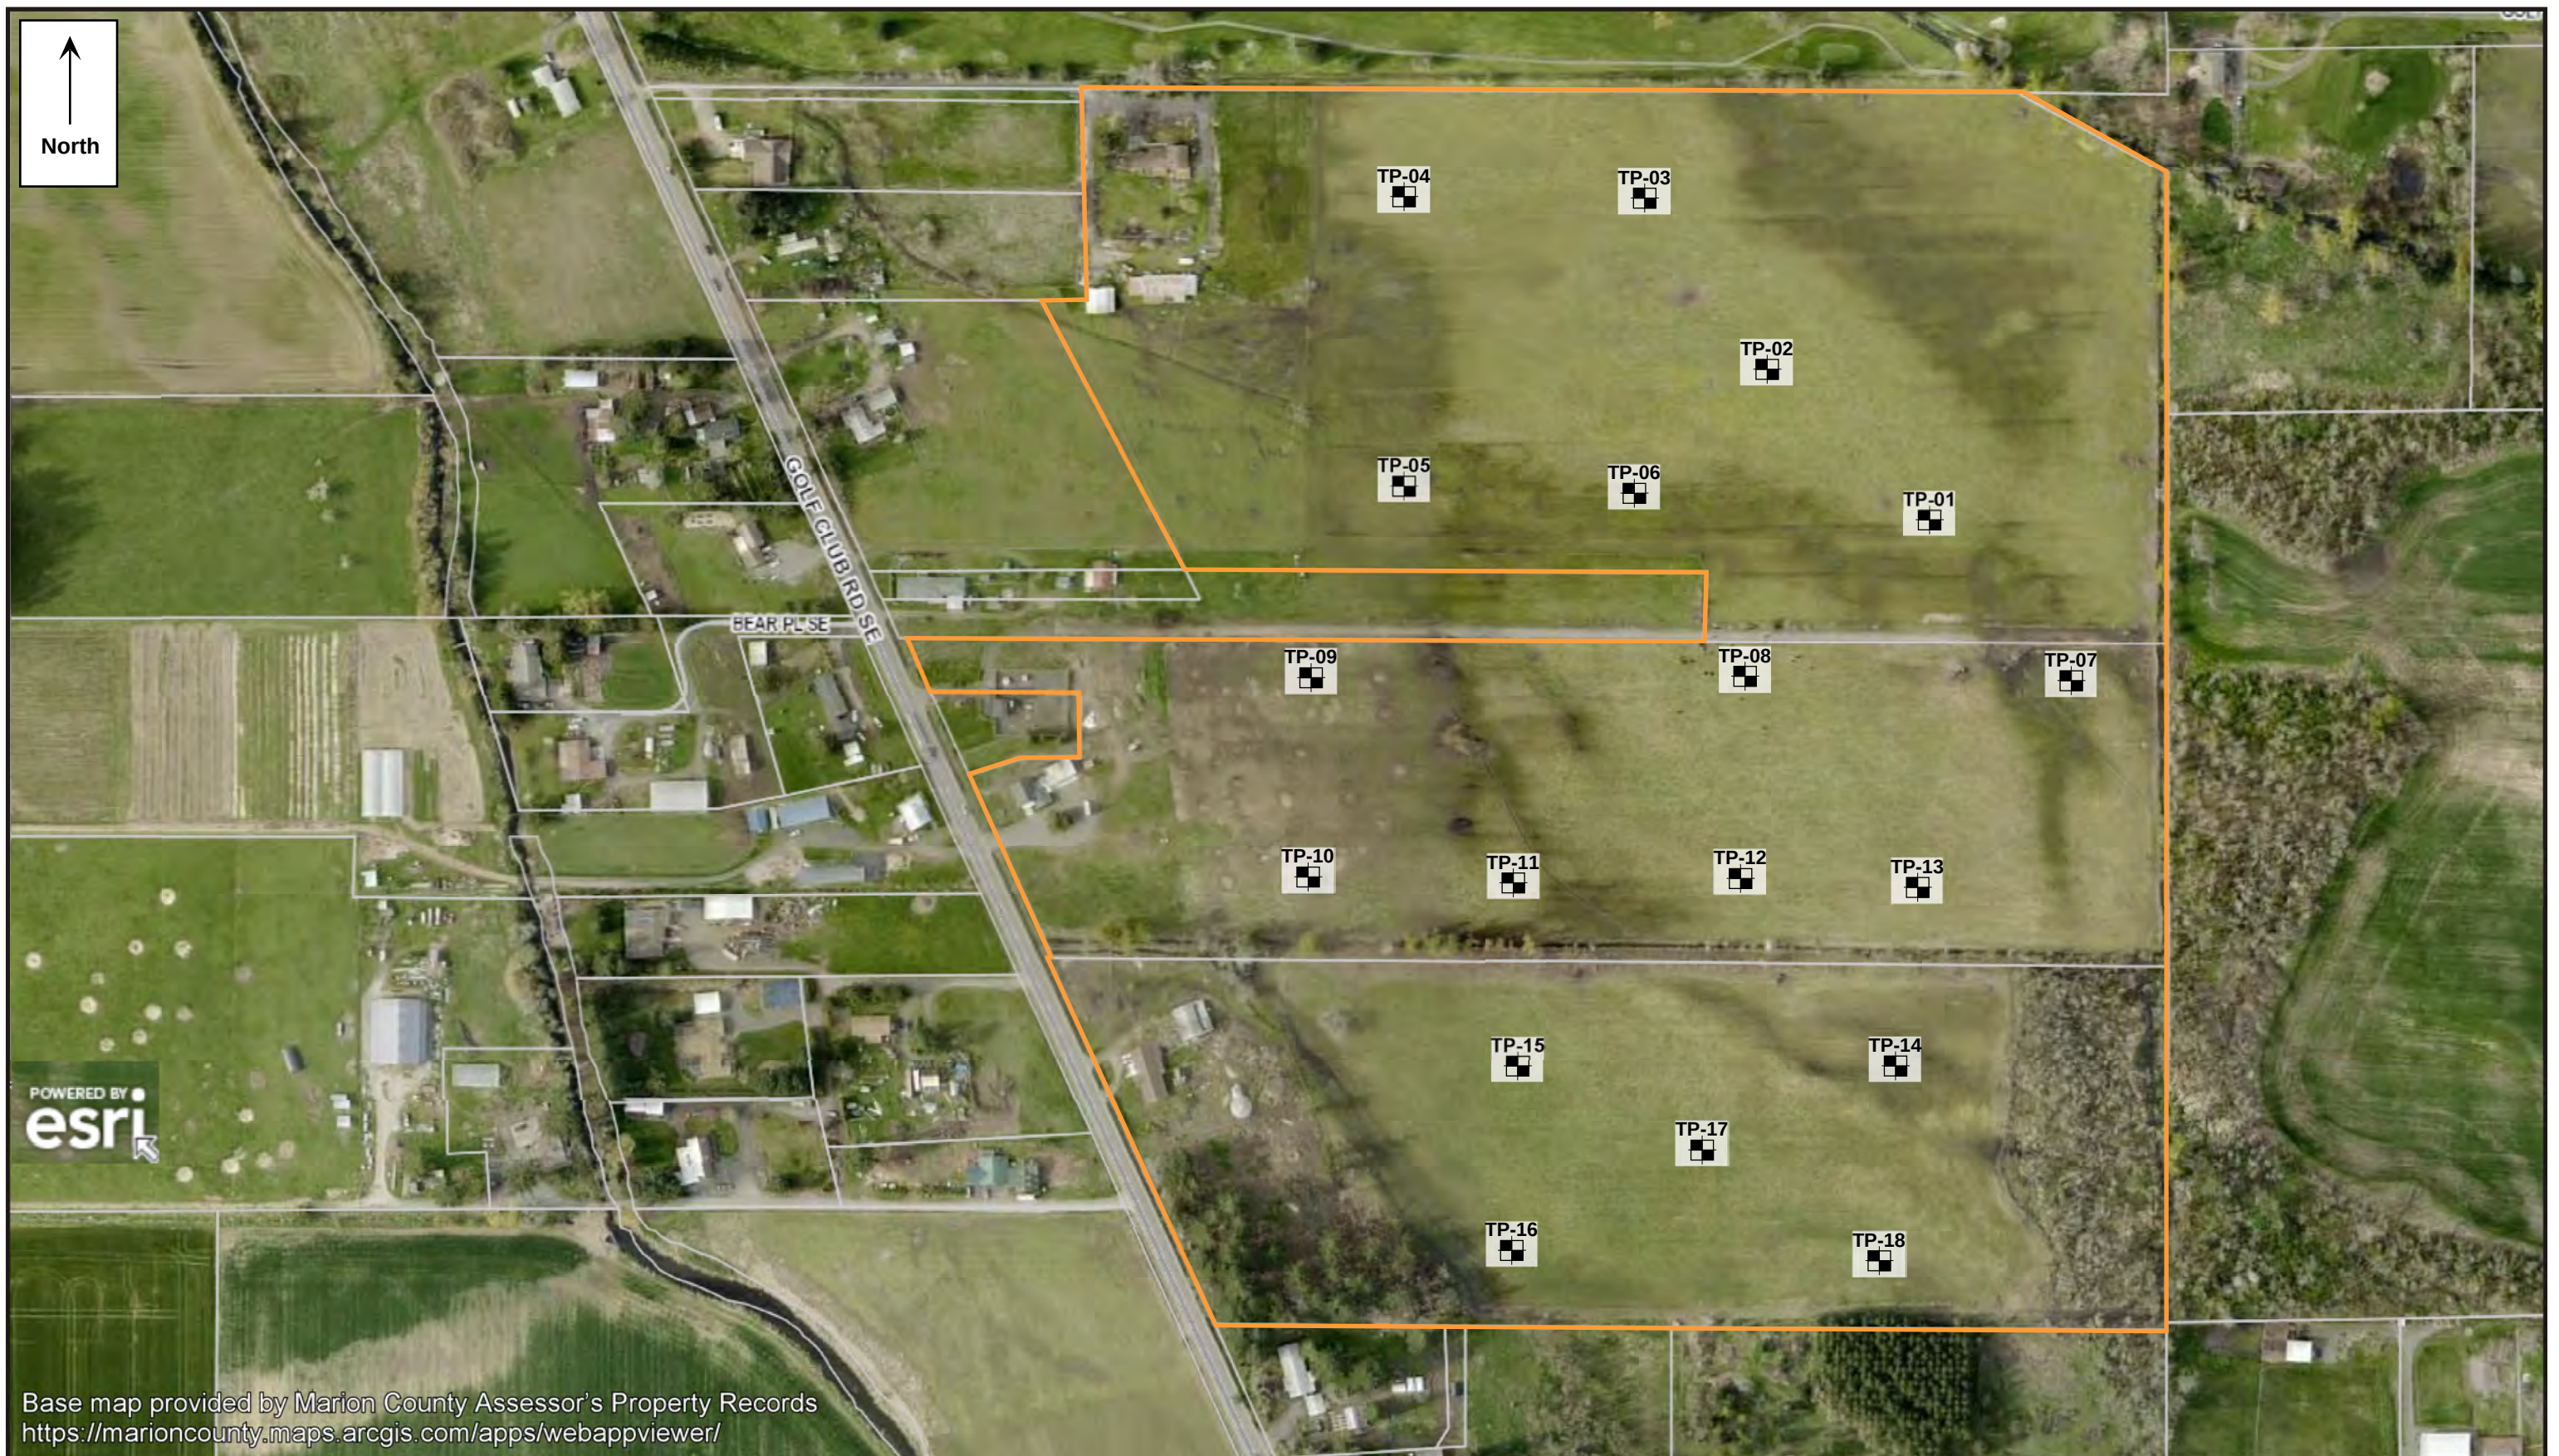
| <b>Legend</b><br>Date: 12.26.2024<br>Note: Location of all geotechnical information is approximate. | | <b>TP-1</b><br><br>Test Pit Designation and Approximate Location | | <b>SCALE</b><br>0 250 500 FEET<br>1 INCH = 250 FEET | | <b>GEO PACIFIC</b> 14835 SW 72nd Avenue<br>Portland, Oregon 97224<br>503-598-8445 | | <b>SITE AERIAL AND EXPLORATION LOCATIONS</b> | | | | | |

It should be noted that our explorations were located in the field by pacing or taping distances from apparent property corners and other site features shown on the plans provided. As such, the locations of the explorations should be considered approximate. Summary exploration logs are attached. The stratigraphic contacts shown on the individual test pit logs represent the approximate boundaries between soil types. The actual transitions may be more gradual. The soil and groundwater conditions depicted are only for the specific dates and locations reported, and therefore, are not necessarily representative of other locations and times. Soil and groundwater conditions encountered in the explorations are summarized in the following *Soil Descriptions* section.
